# GOBIERNO DE PUERTO RICO

DEPARTAMENTO DE EDUCACIÓN

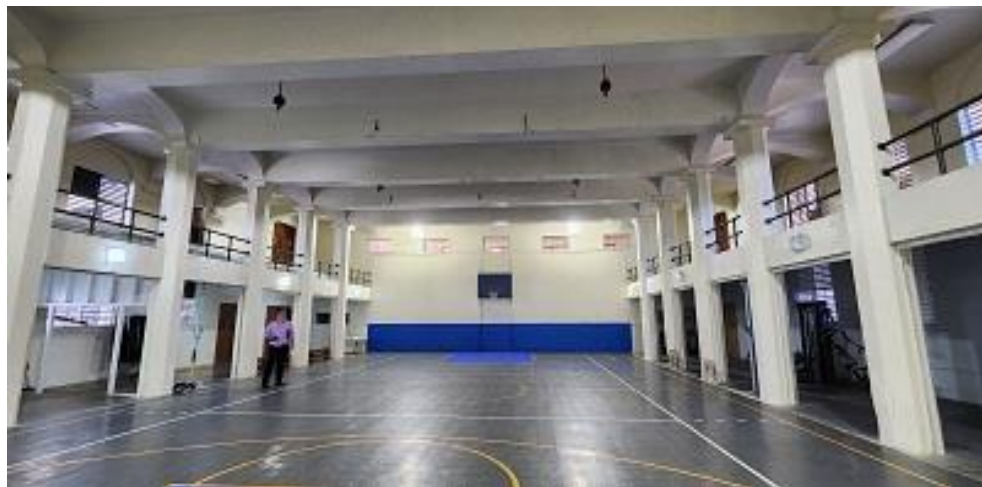
**1. Vista general de la cancha.**

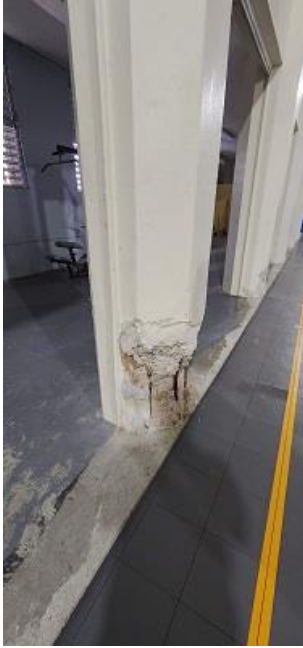
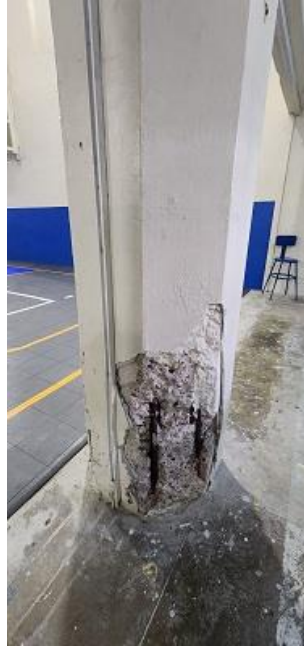
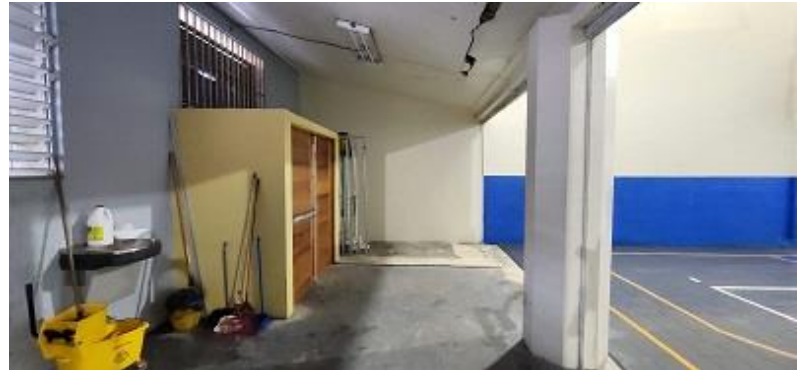
**2. Parte baja de varias de las columnas de hormigón armado de la cancha que muestran deterioro por corrosión de los refuerzos de acero y plafón bajo las gradas al Oeste de la cancha con desprendimientos.**

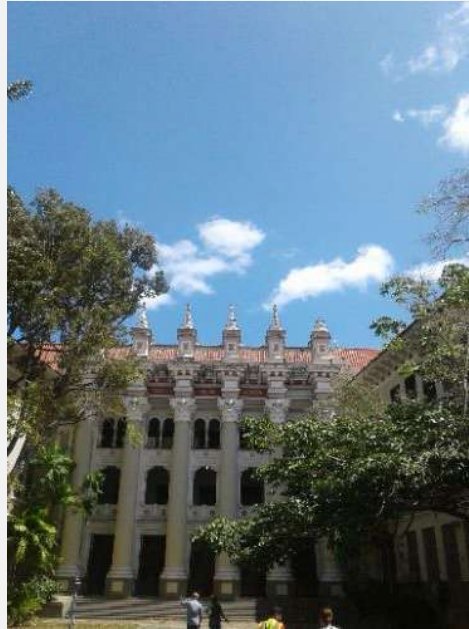
## Site Photograph(s)

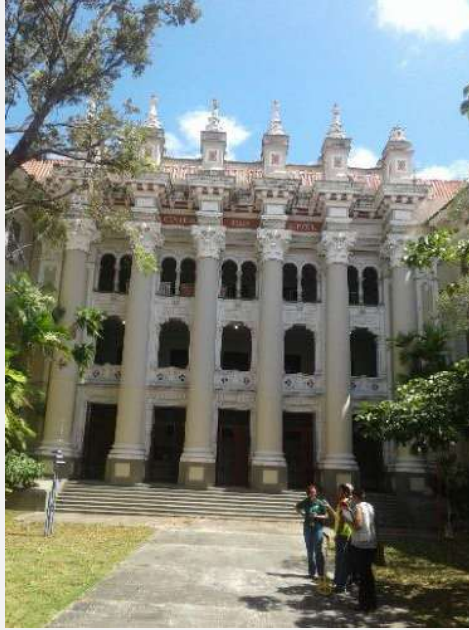
### Damage Description

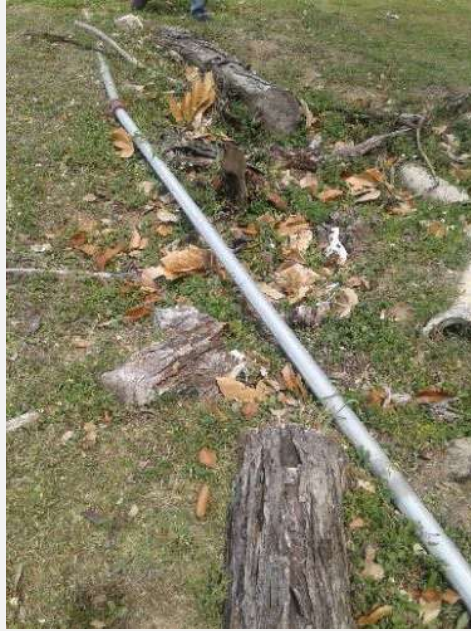
**Site Photograph(s)**

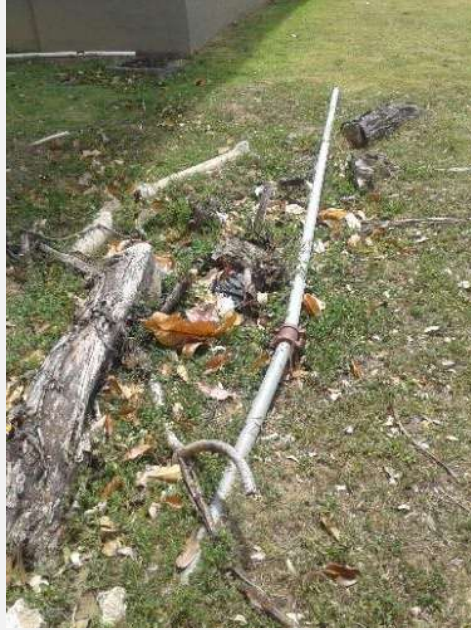
**Damage Description**

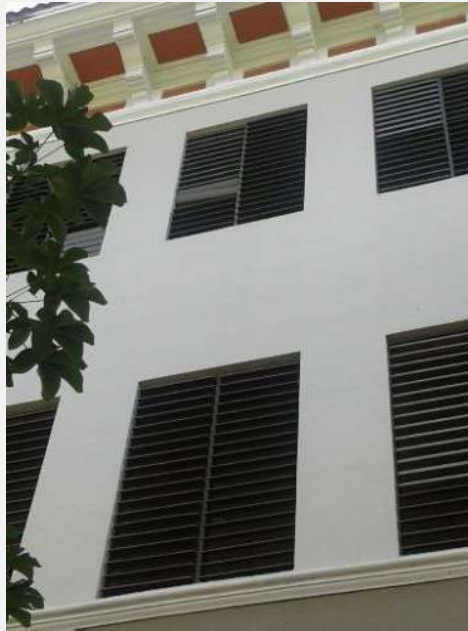
**Site Photograph(s)**

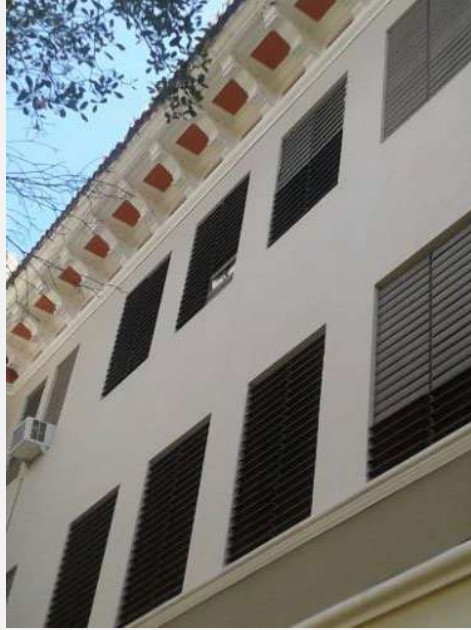
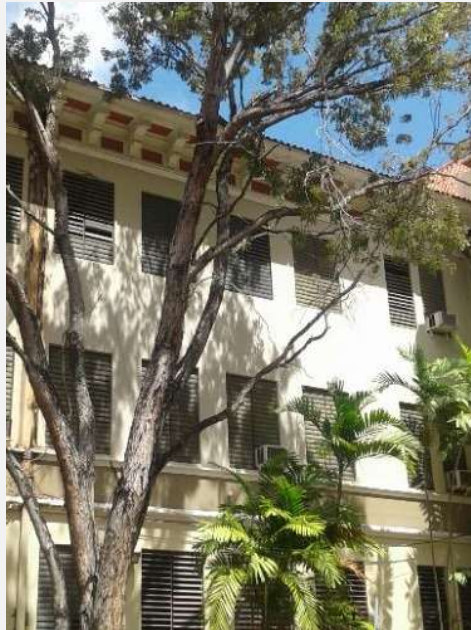
**Damage Description**

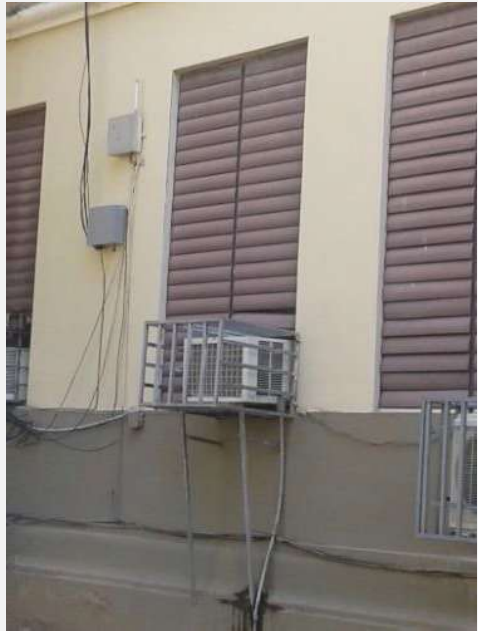
**Site Photograph(s)**

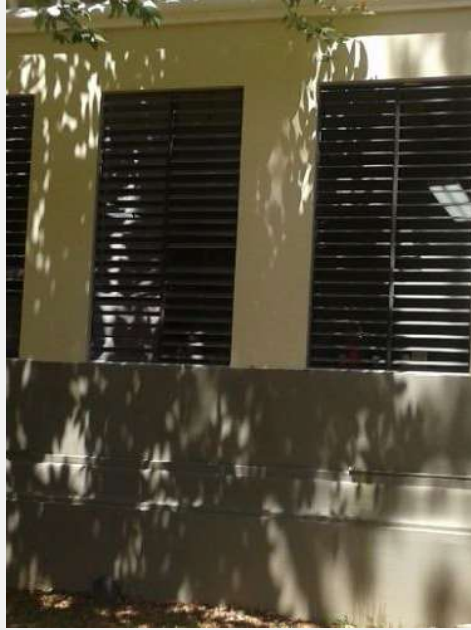
**Damage Description**

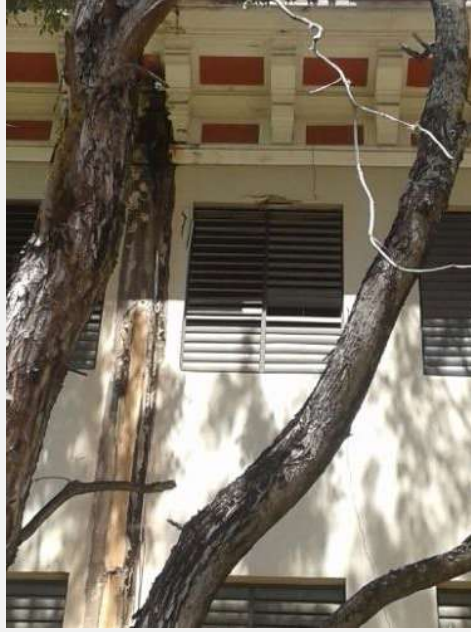
**Site Photograph(s)**

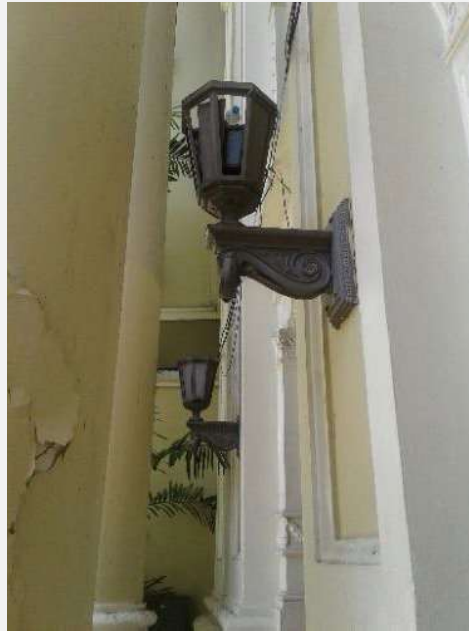
### Site Photograph(s)

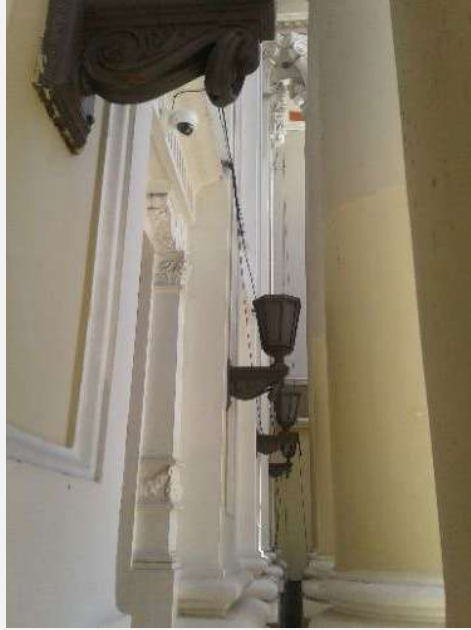
**Damage Description**

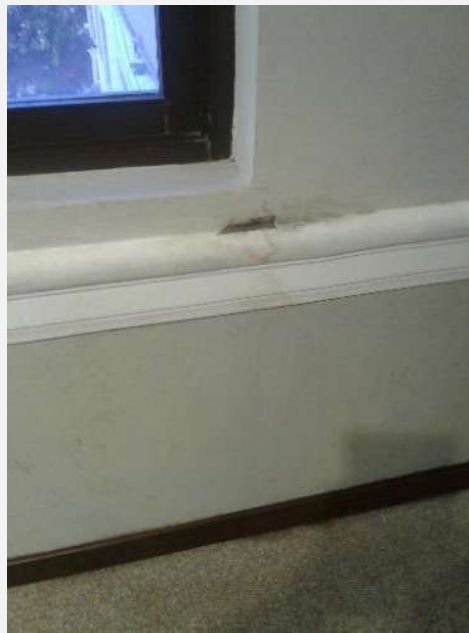
**Site Photograph(s)**

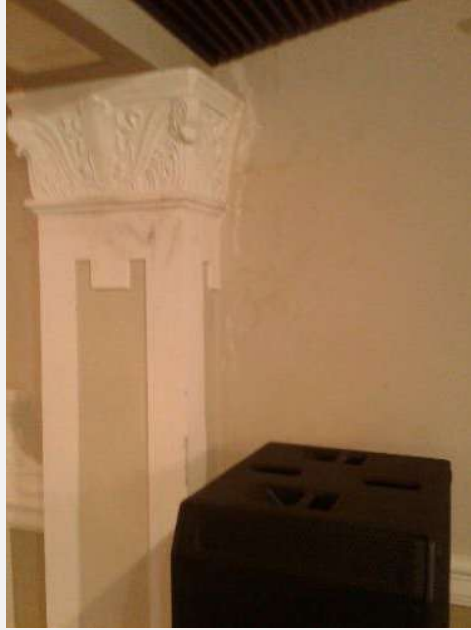
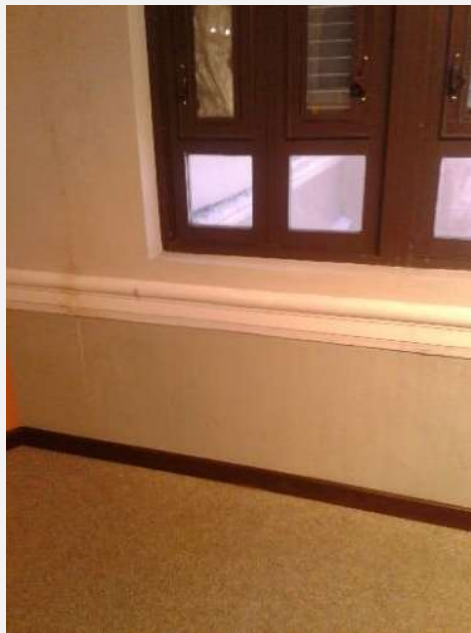
### Damage Description

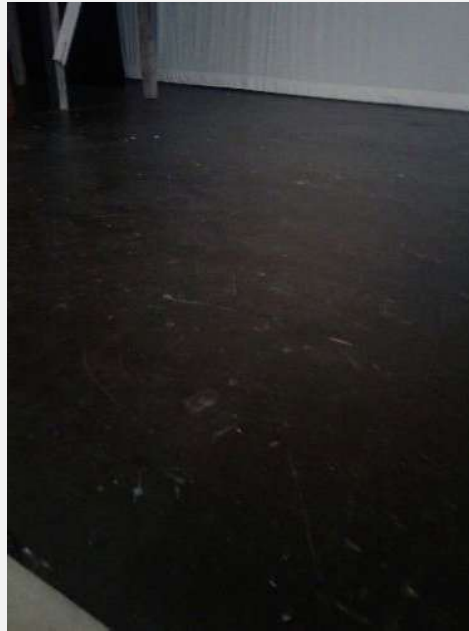
### Site Photograph(s)

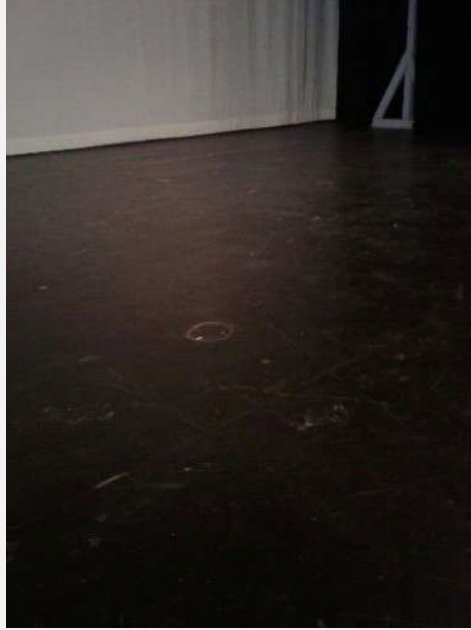
**Damage Description**

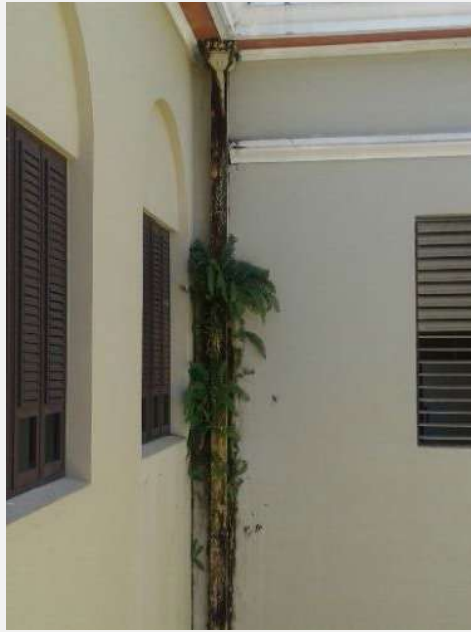
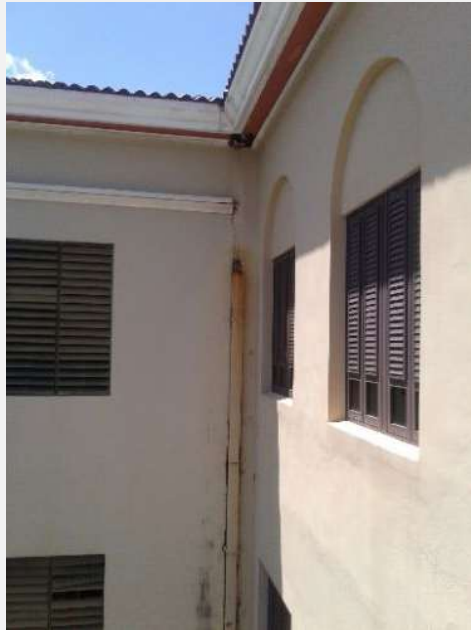
**Damage Description**

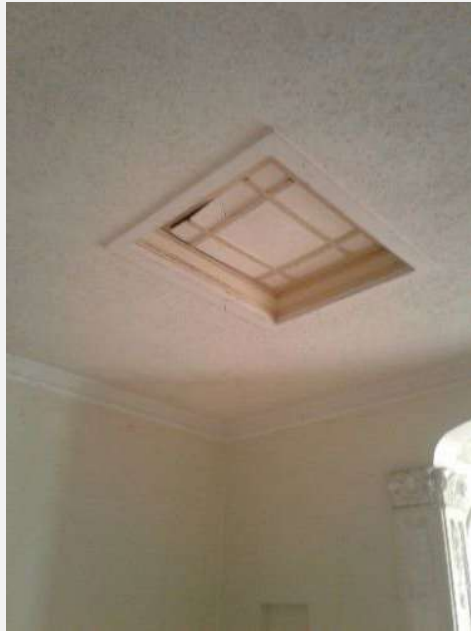
**Damage Description**

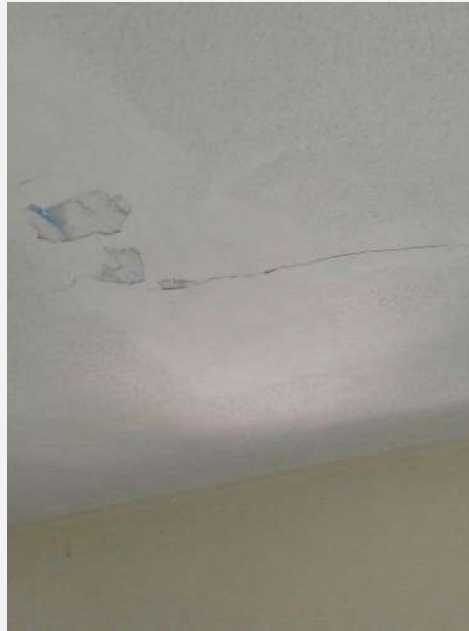
### Damage Description

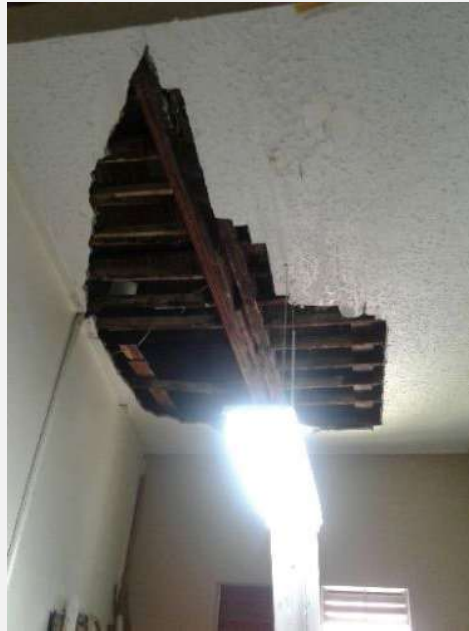
### Site Photograph(s)

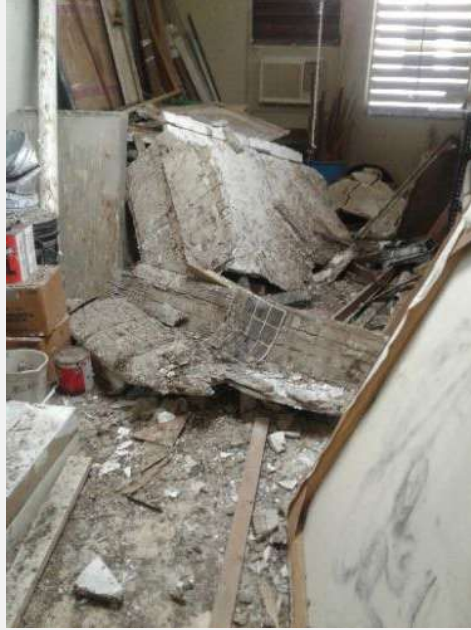
**Damage Description**

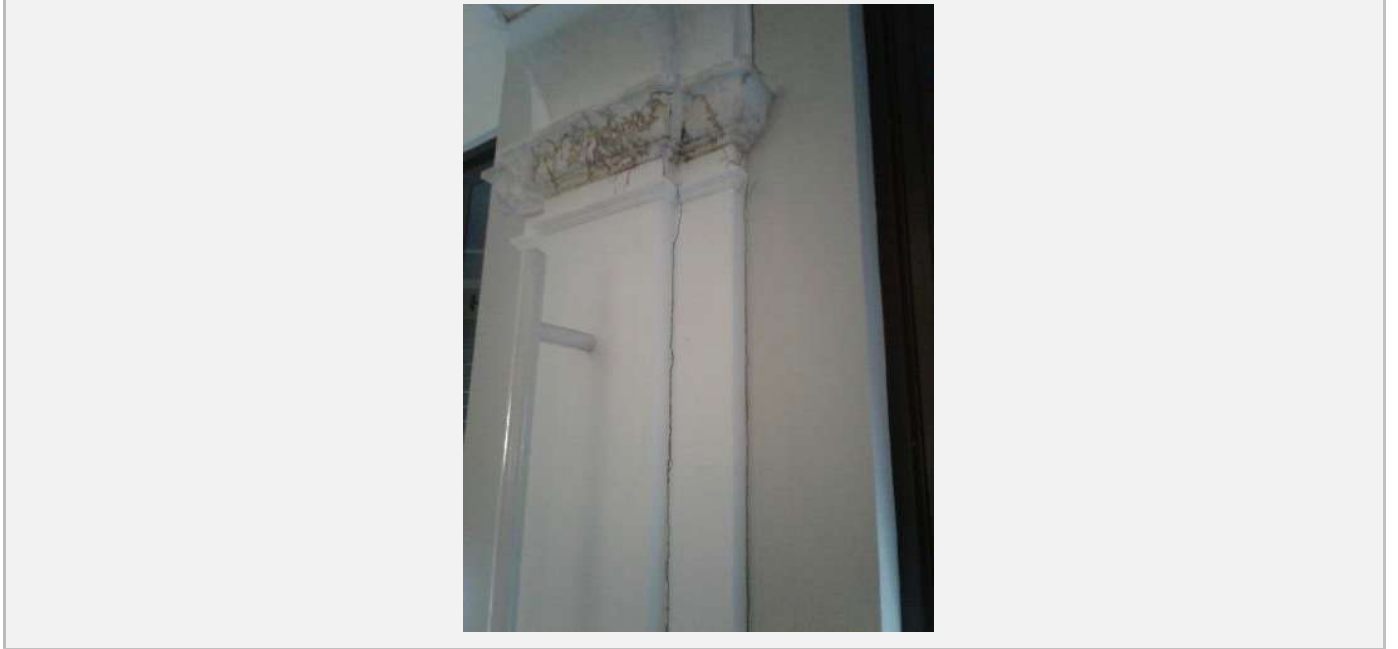
**Site Photograph(s)**

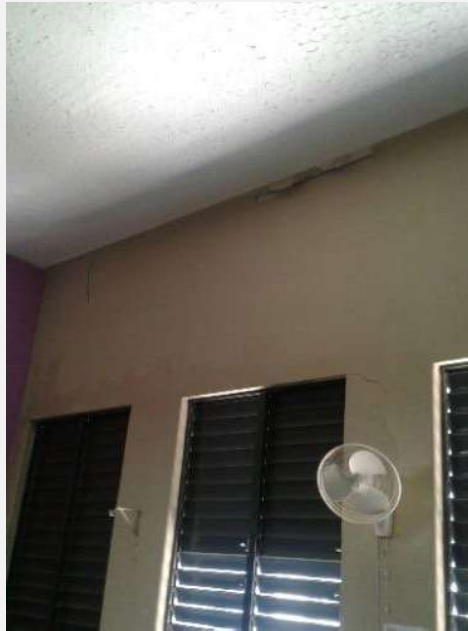
**Damage Description**

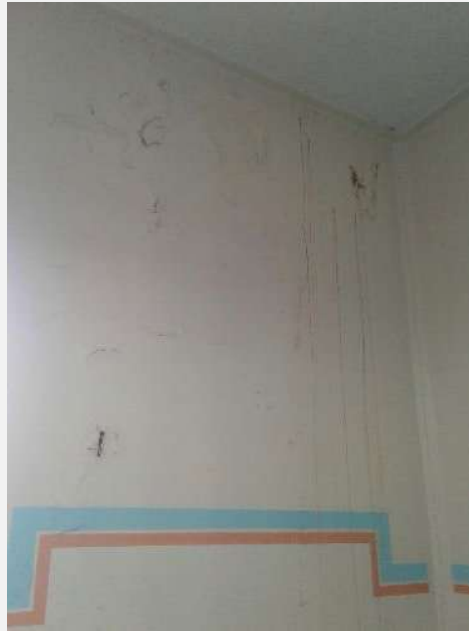
### Damage Description

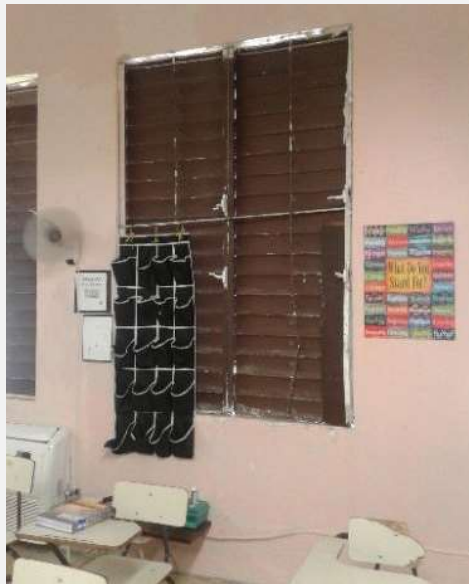
### Site Photograph(s)

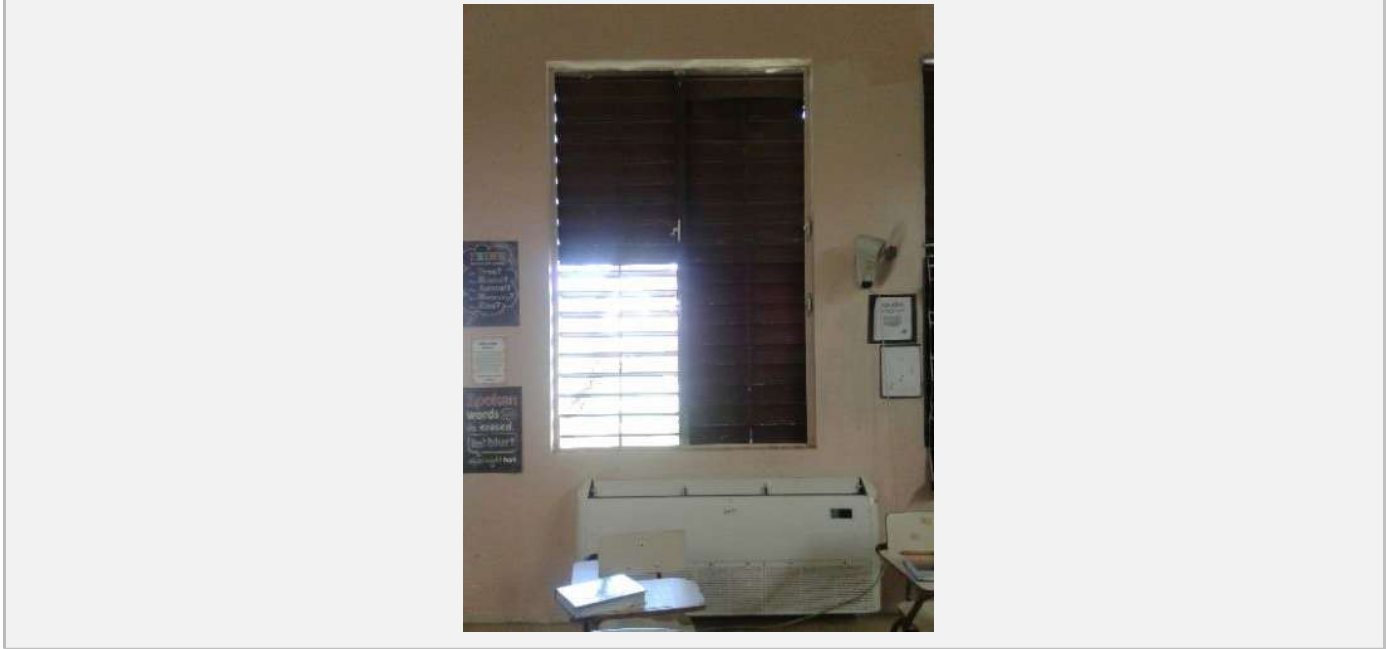
**Damage Description**

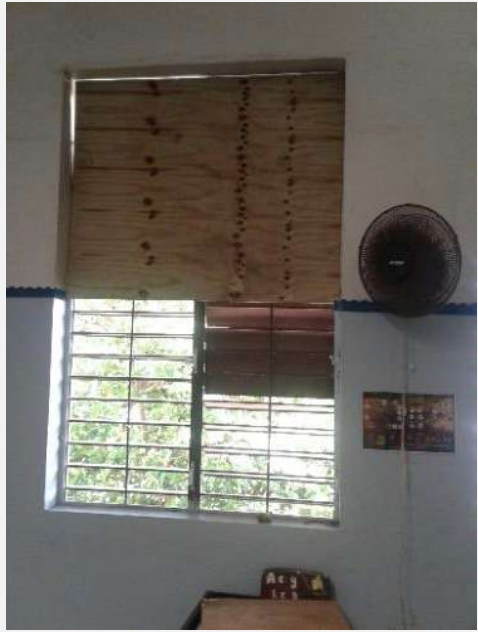
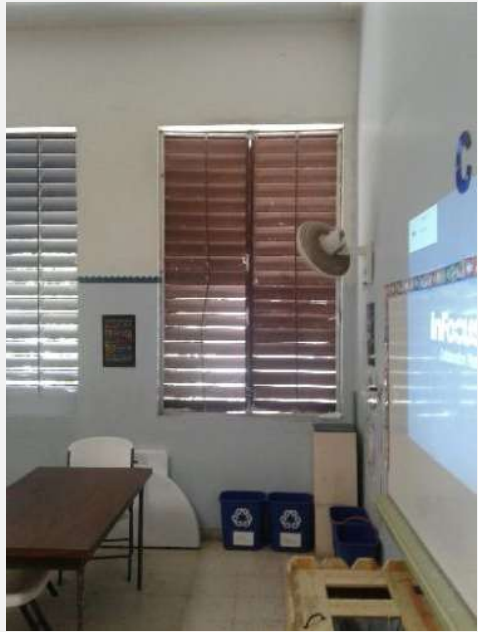
**Damage Description**

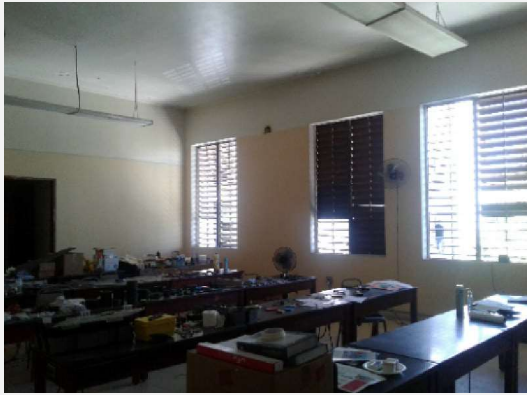
**Site Photograph(s)**

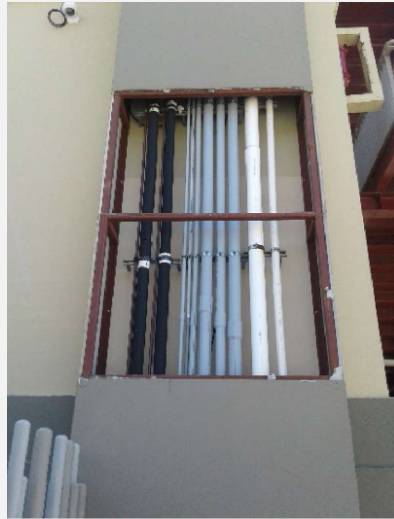
### Damage Description

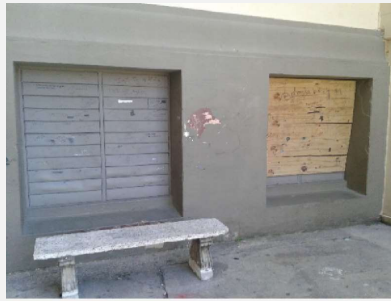
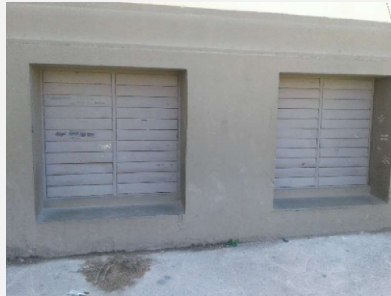
### Damage Description

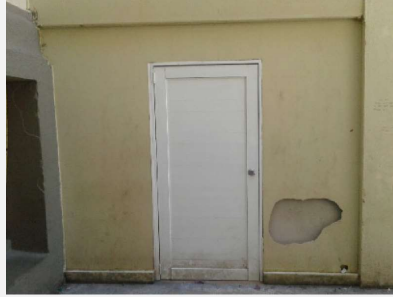
**Site Photograph(s)**

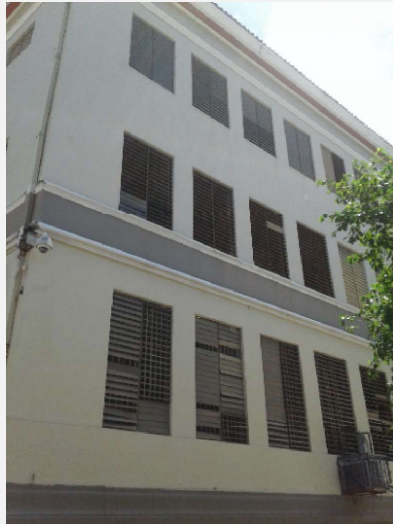
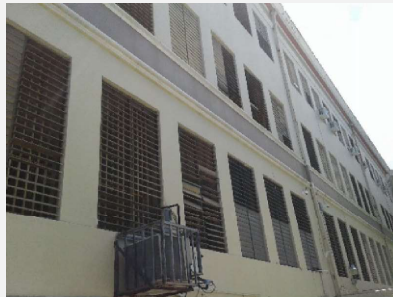
**Damage Description**

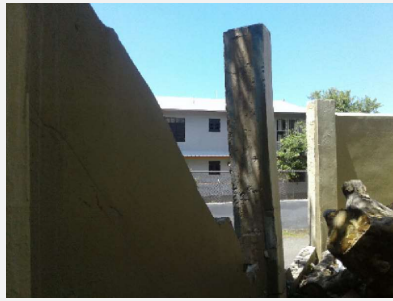
### Damage Description

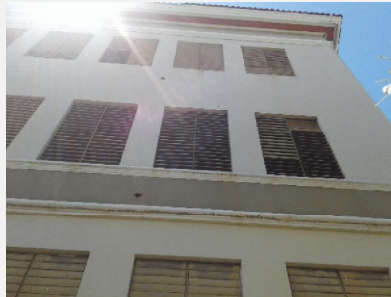
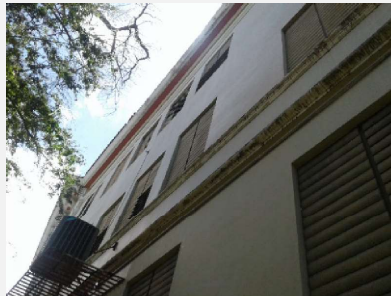
### Damage Description

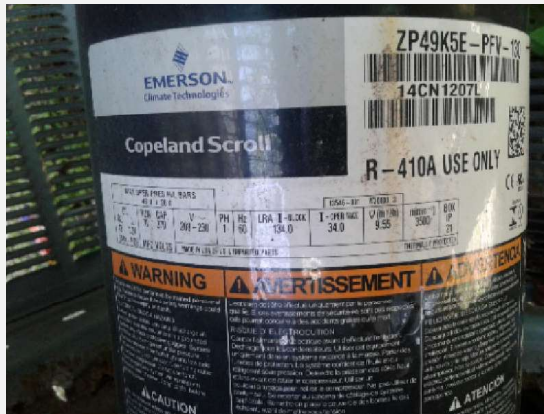
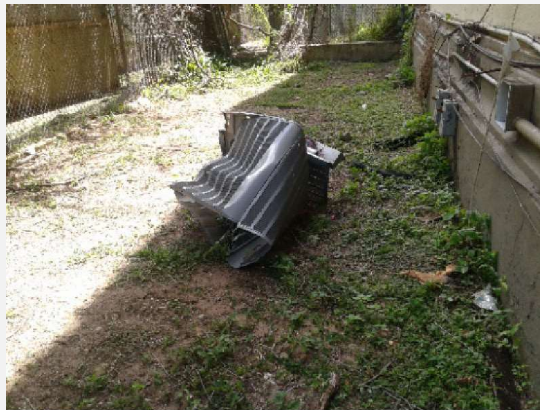
**Damage Description**

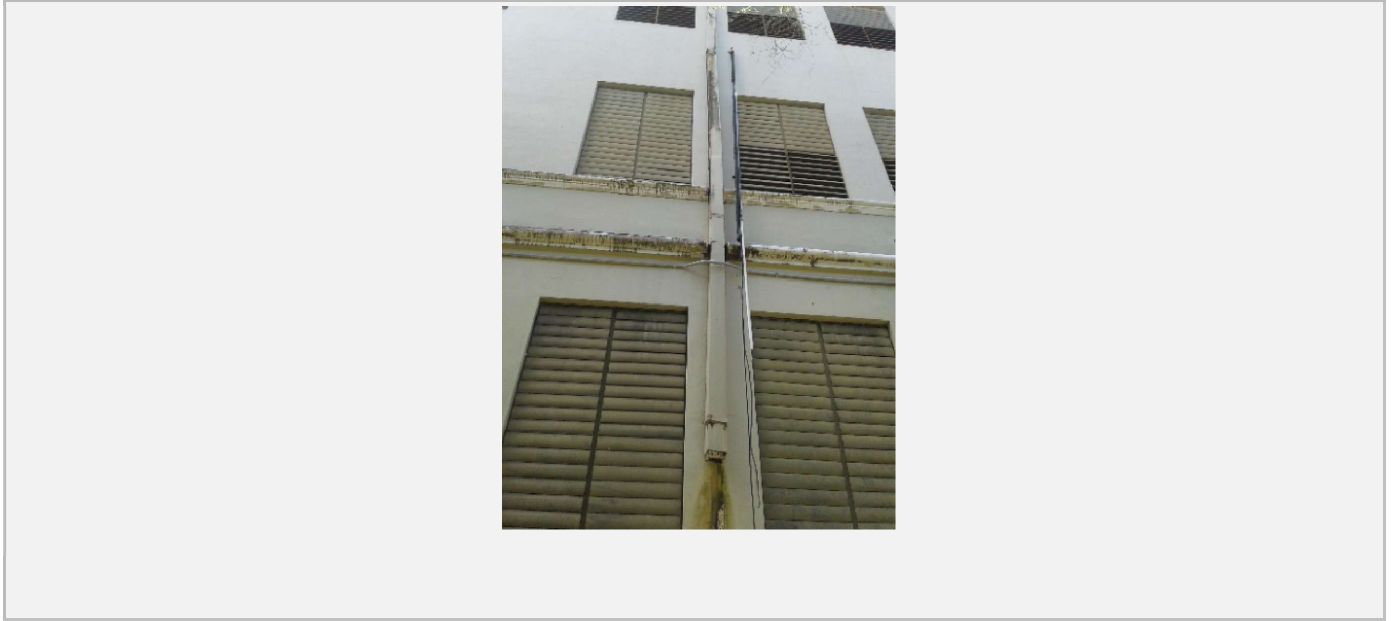
**Site Photograph(s)**

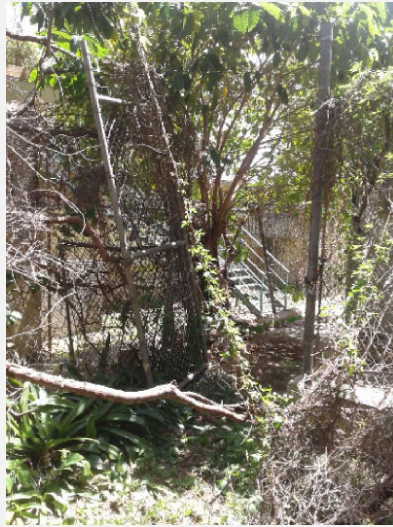
**Damage Description**

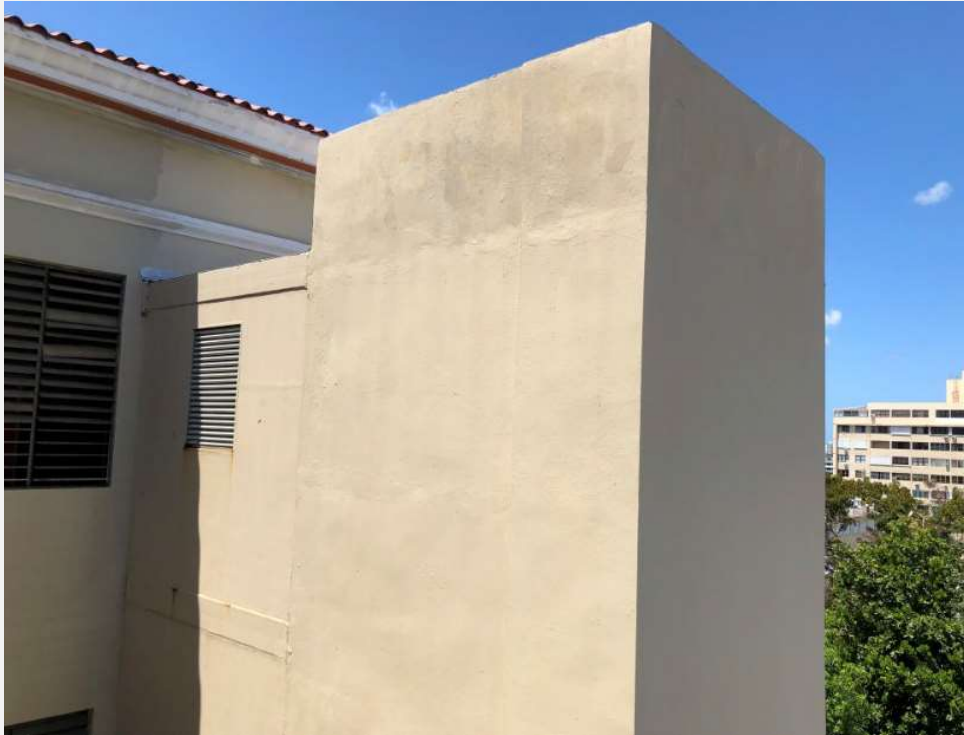
**Damage Description**

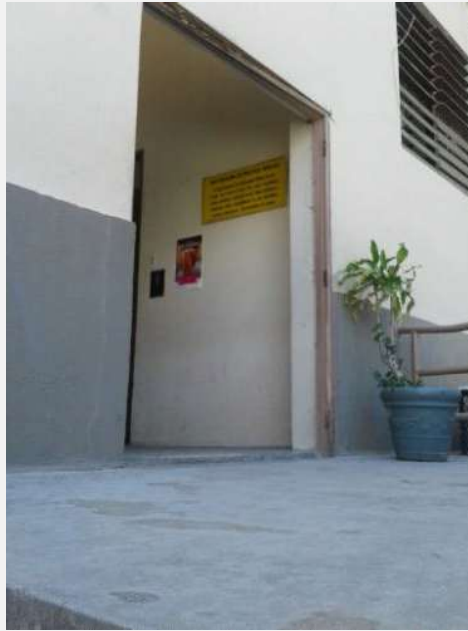
### Site Photograph(s)

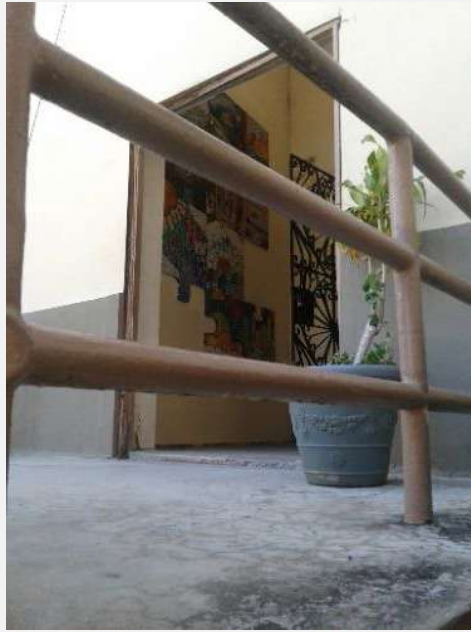
**Damage Description**

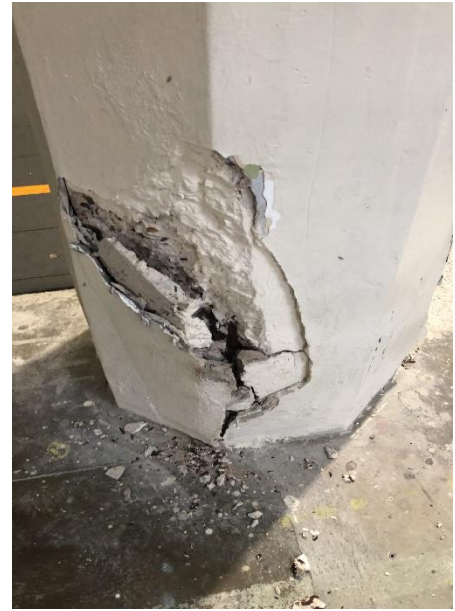
*Ilustración 38. Columnas con grietas en la cancha*

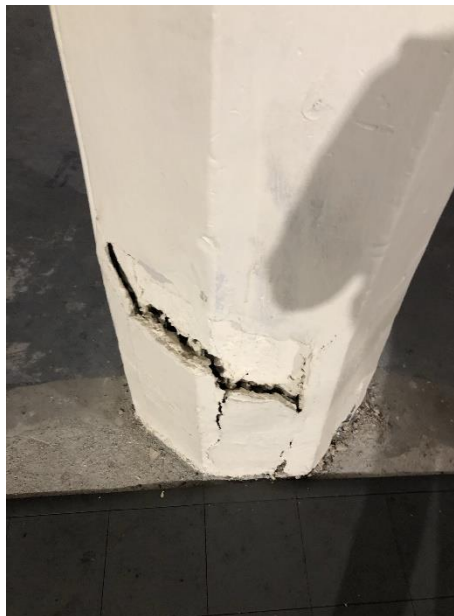
*Ilustración 39. Columnas con grietas en la cancha*

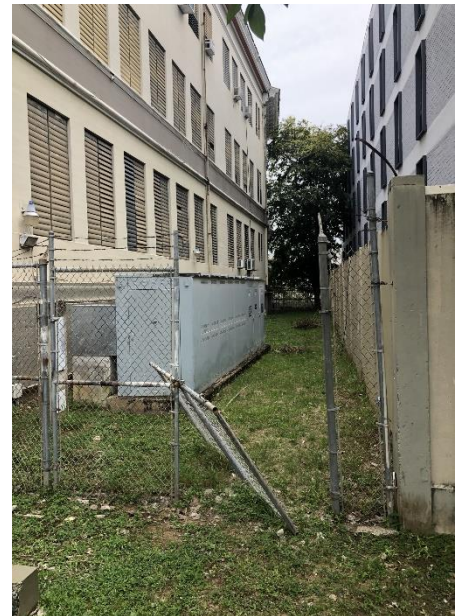
*Ilustración 40. Realizar mantenimiento a la subestación*
