**GOBIERNO DE PUERTO RICO**  
DEPARTAMENTO DE RECREACIÓN Y DEPORTES

**INFORME SENATORIAL MUNICIPIO DE VEGA BAJA**

## Damage assessment Report

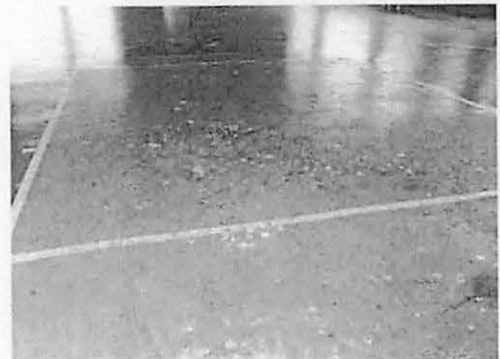
Pest 01

Birds

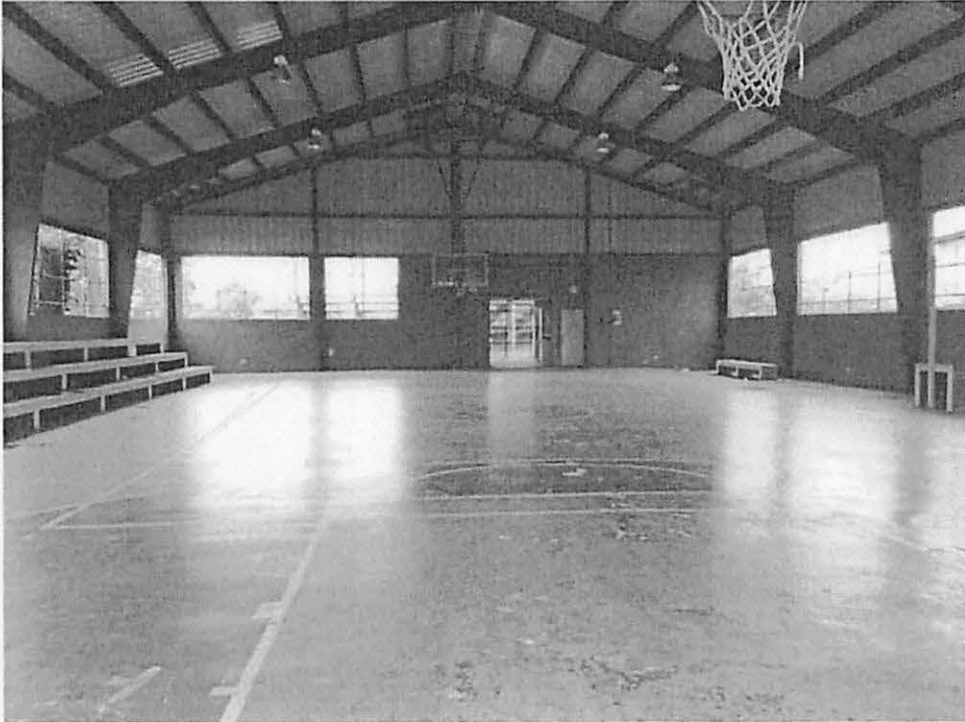
| Basketball Photo | Court Photo 01 |

| Section roof missing alone age at entrance | |
| Type of Roof Damage | Missing Sections |

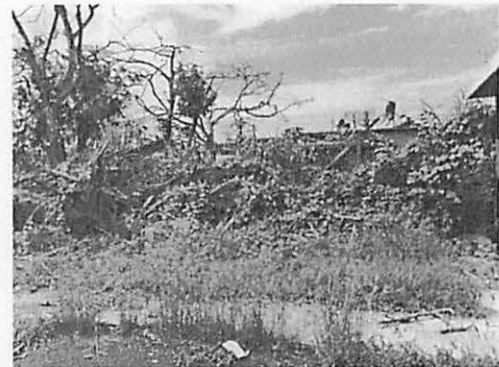
Debris on Ground Debris 01

Large debris pile next to massive stamps next to concession stand and restrooms in the baseball park area pose a safety hazard to baseball Park users and pedestrians.

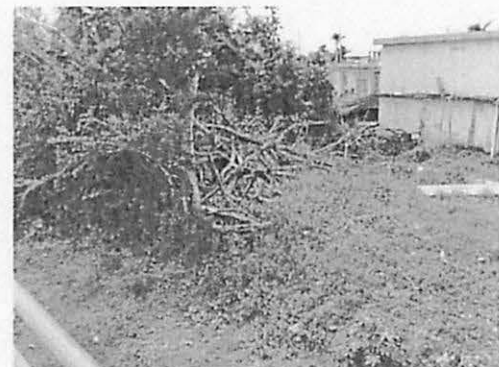
Debris 02

Large debris pile behind baseball park bleachers poses a safety hazard to baseball park users and pedestrians.

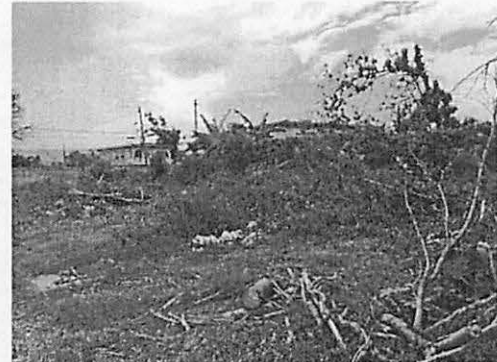
Debris on Ground      Debris 03

Multiple debris piles along the first base line of the baseball park poses a safety hazard to baseball park users and pedestrians.

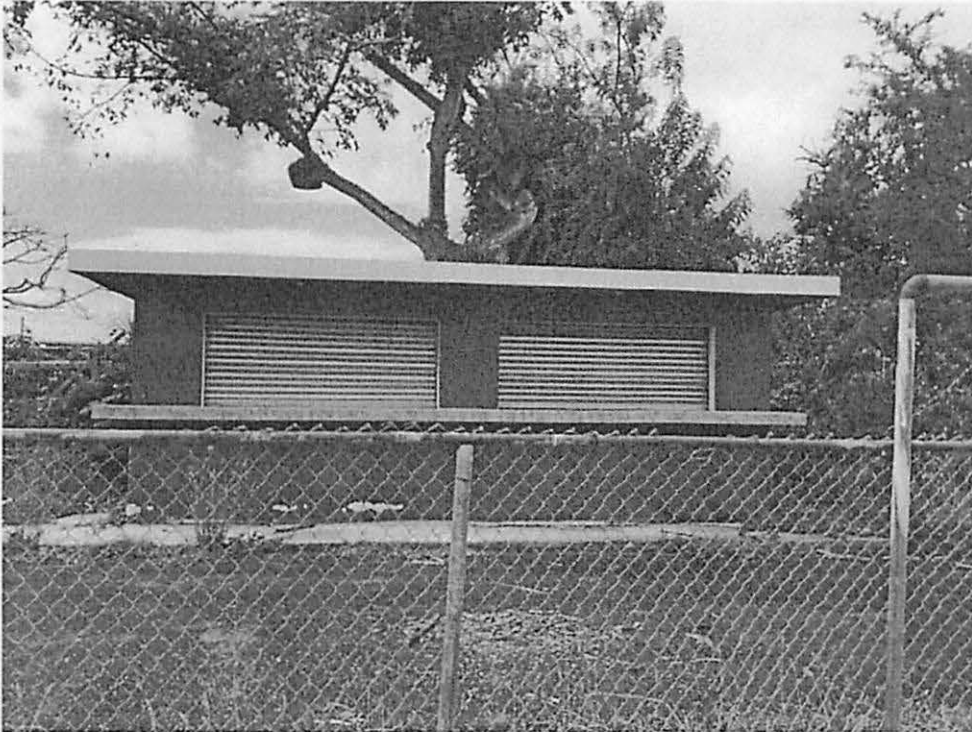
**BUILDINGS (OFFICES, RENTAL VILLAS, ETC.)****Building Type****Concession Stand 01****BUILDING DAMAGE**

Restrooms in the baseball Park area seem to have some damage to the roof and vegetative debris on the roof

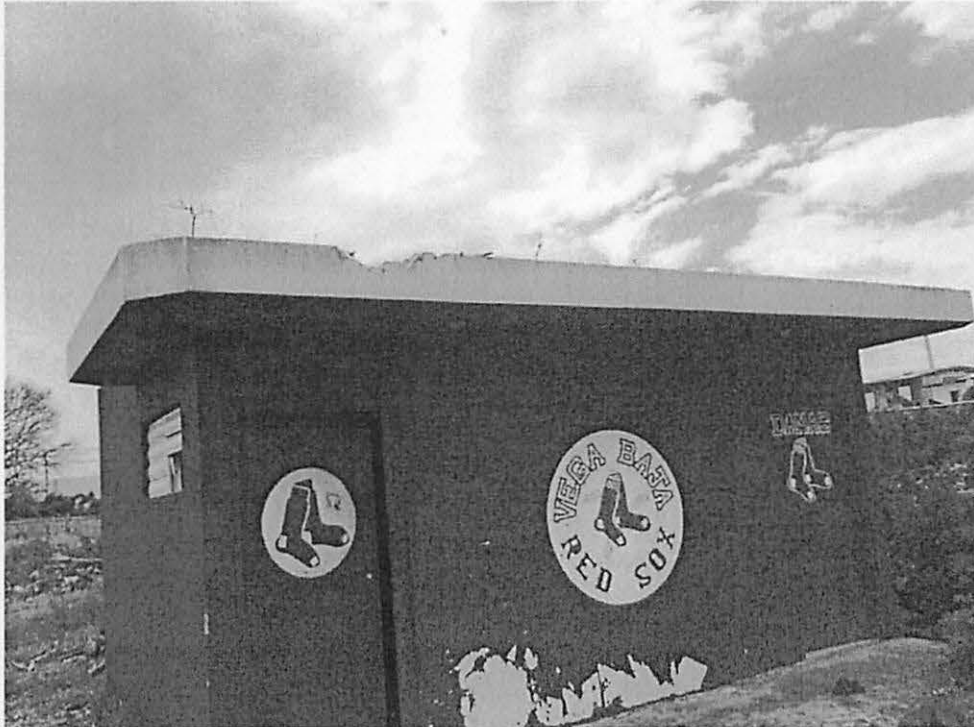
| Roof Damage | |

Type of Damage

Missing Sections

| Approximate % of roof area damaged | 10 |

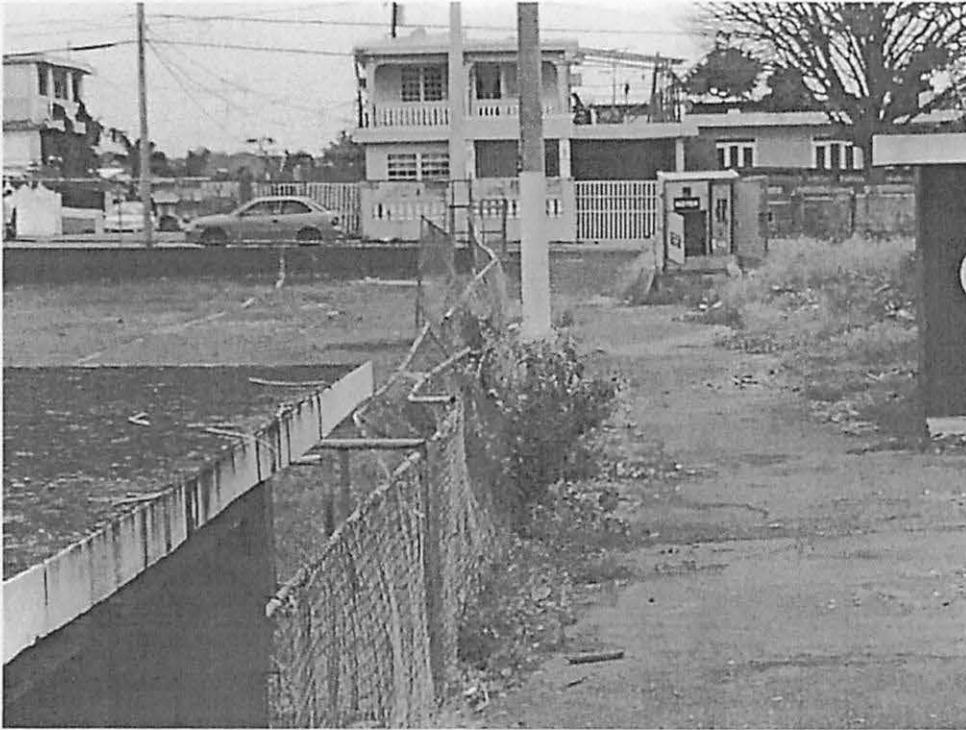
Baseball Fence 01

Damaged fence down first base line all the way through outfield poses a safety hazard to baseball park users and pedestrians.

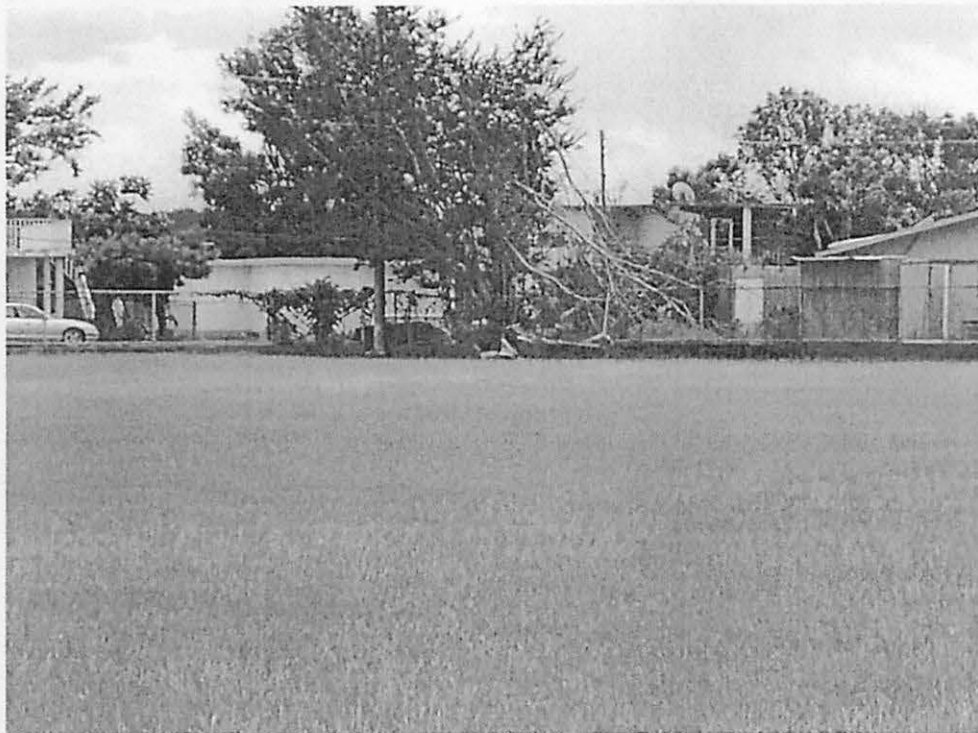
Baseball Fence 02

| Damage to fence in left center field poses a safety hazard to baseball park users and pedestrians. | |

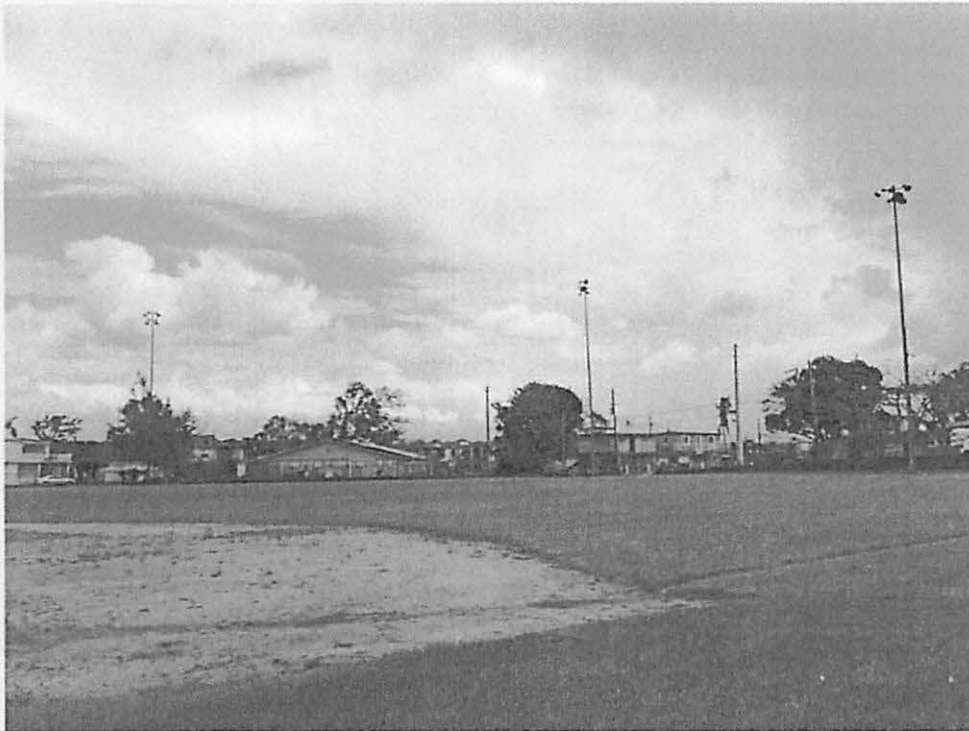
## Example of Damaged Lighting

| Light Pole Material | Metal |
| Light Pole Damage | Damaged Bulbs |
| Number of Damaged Poles of this Type | 8 |
| Number of Damaged Bulbs or Fixtures on Pole | 6 |

All baseball lighting poles seem to be in good working order other than it is assumed that all bulbs are broken.

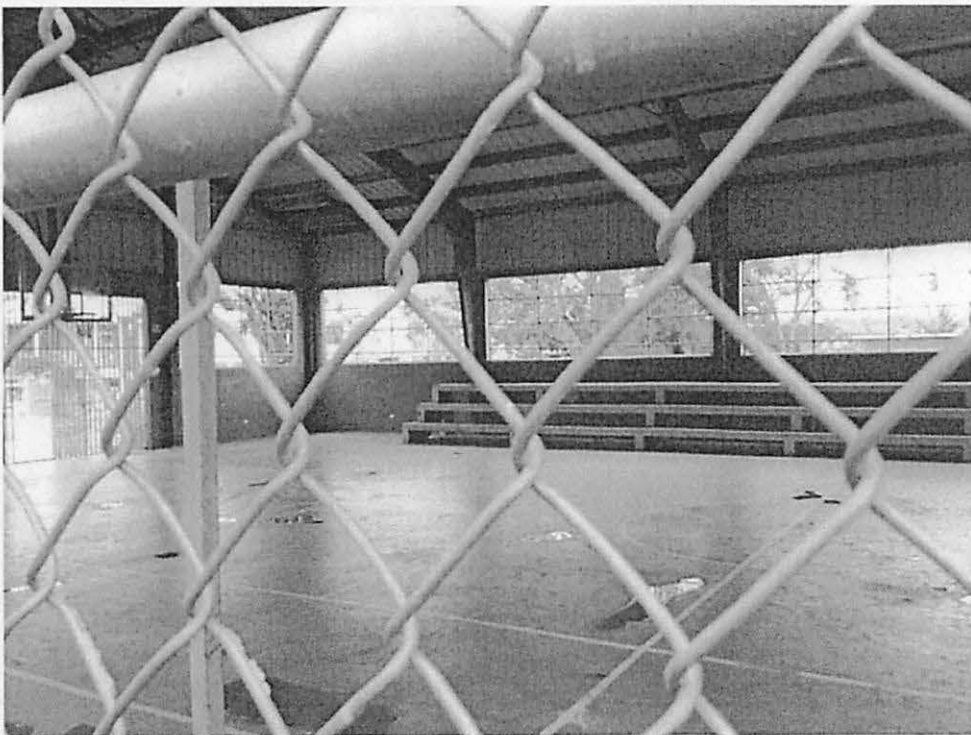
Court Photo 01

Covered basketball court appears to be in good working order and in use.

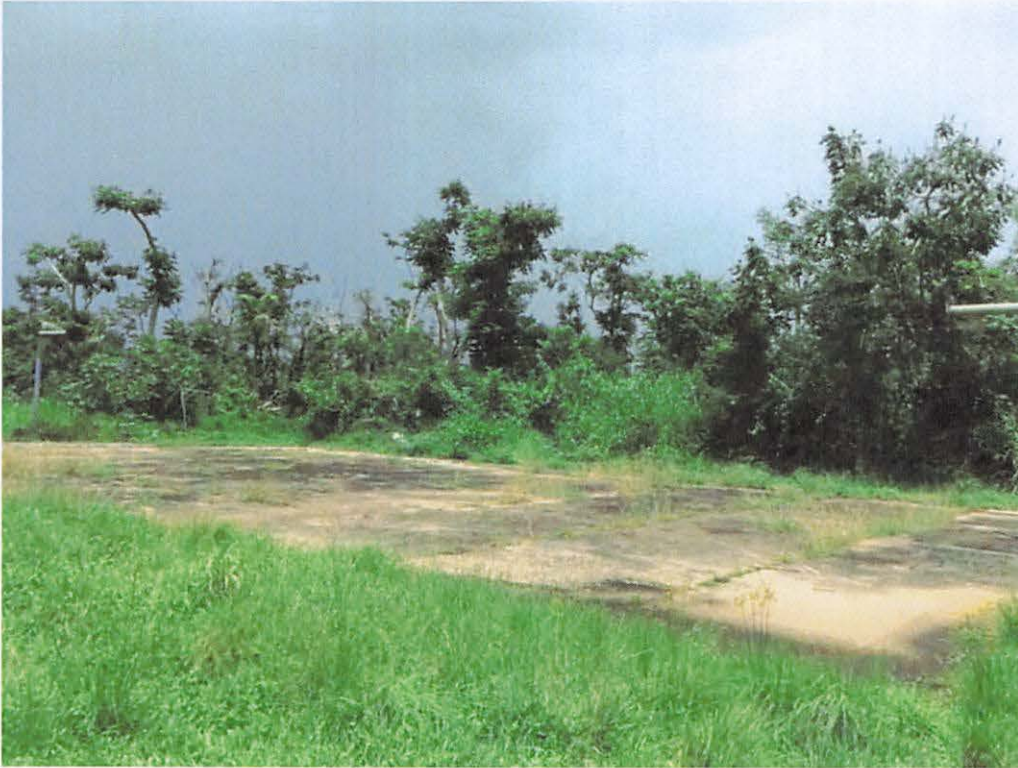
## Basketball Court Photo

Both basketball backboards missing. Neighbor said park has been abandoned over five years

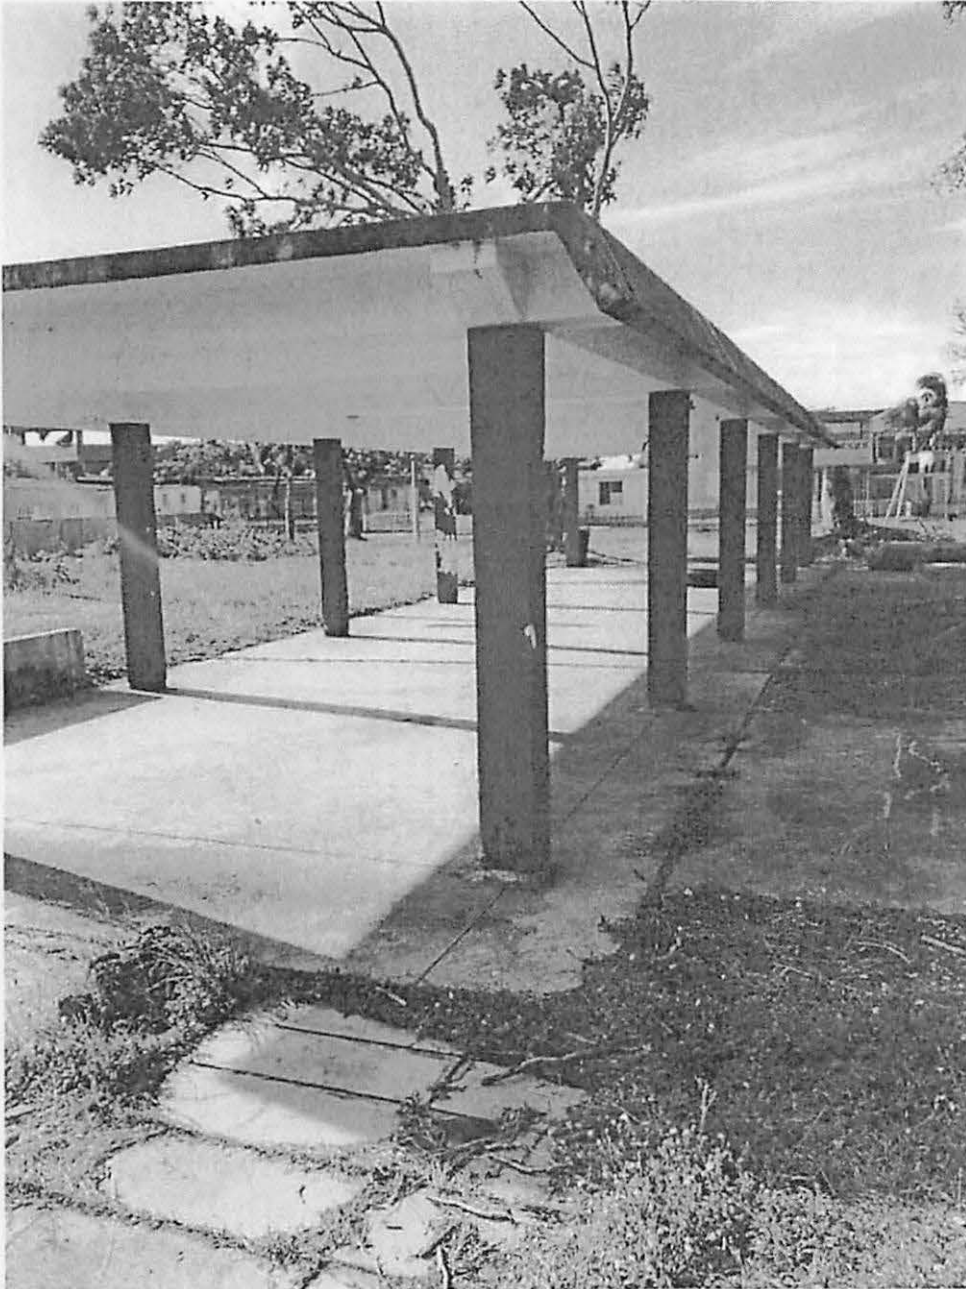
## Gazebo

| Is there a safety hazard at the gazebos? | No |

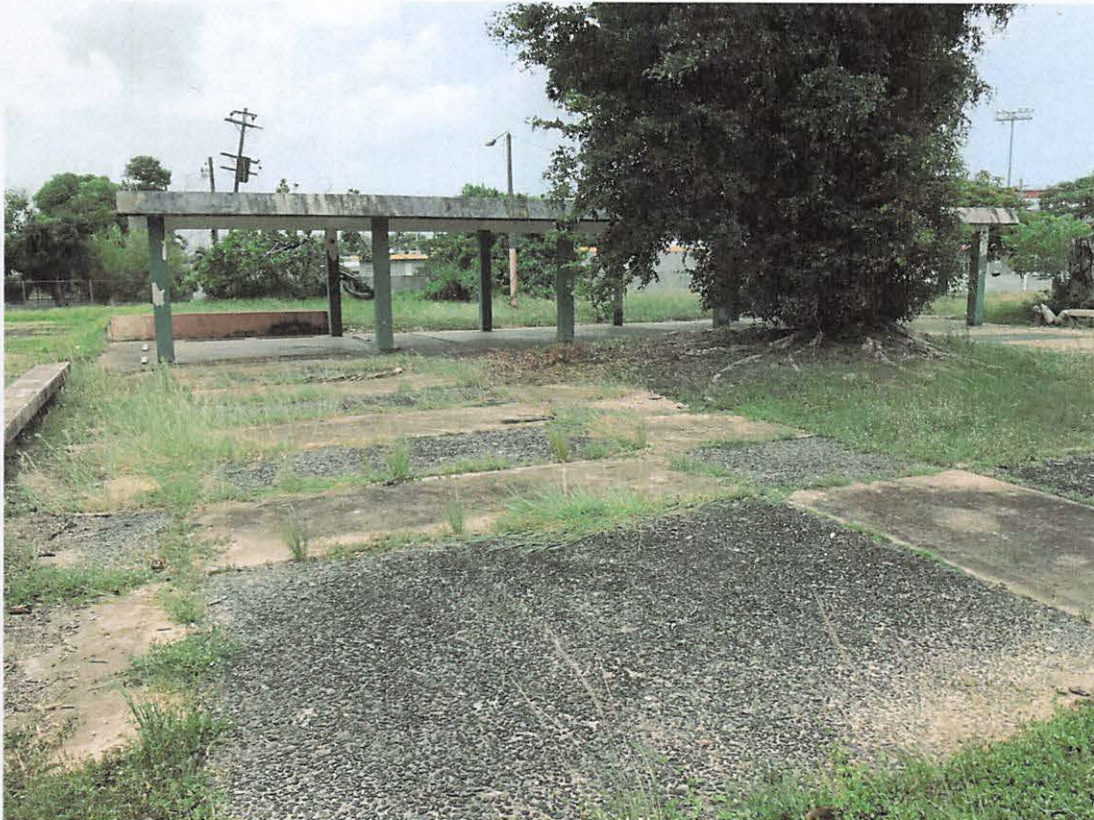
photo 1

On September 20, 2017, Hurricane María made landfall and caused damage to the island of Puerto Rico. Hurricane-force winds, wind-driven rains, floods, heavy rains and debris damaged the entire island of DRD facilities. The Monte Carlo recreational complex in GPS Lat: 18.4478 , Lon: -66.3926, with damage to the floor, ceiling, electrical system, beam and benches.

Remove and replace lights.

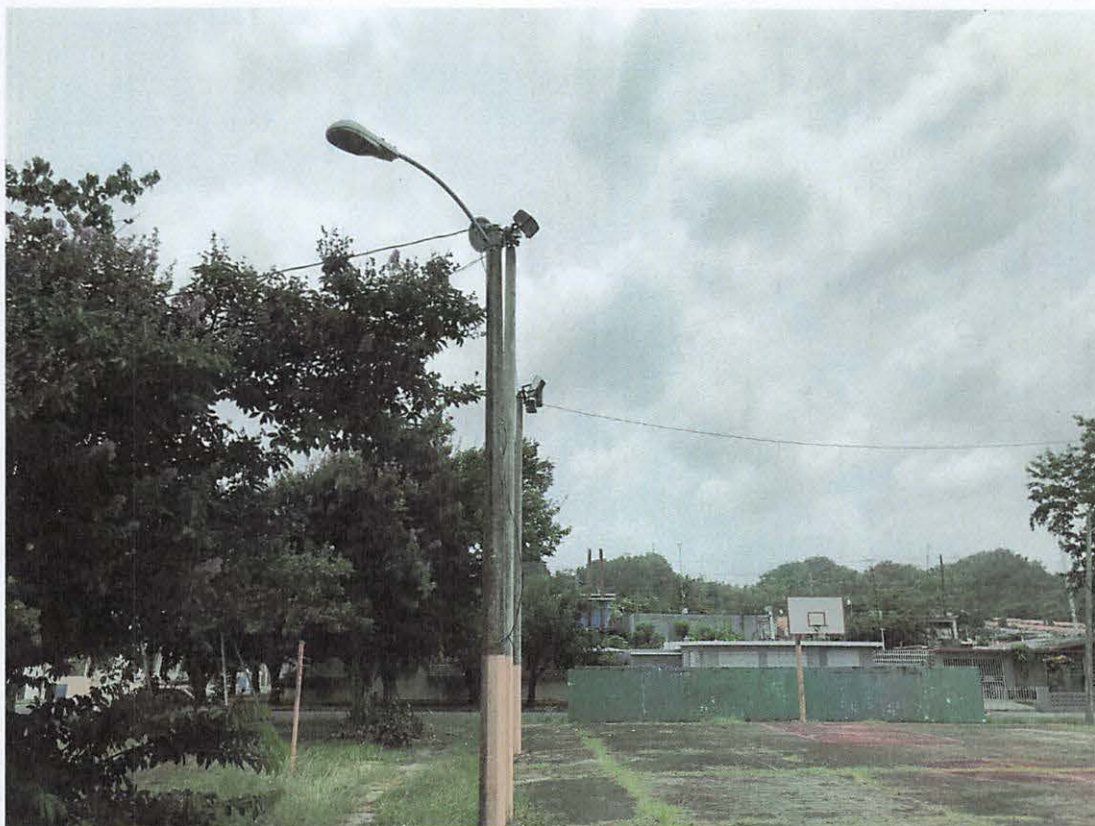
photo 3

Reference photo: 3

Reference photo: 3 and 4

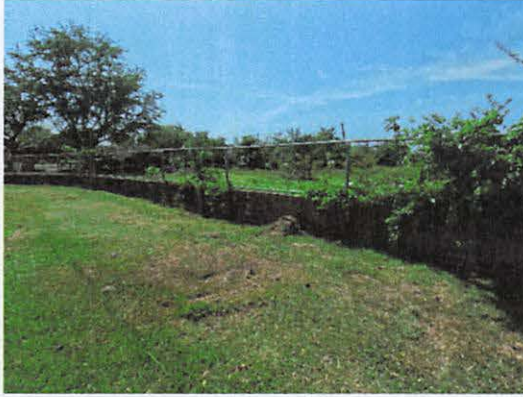
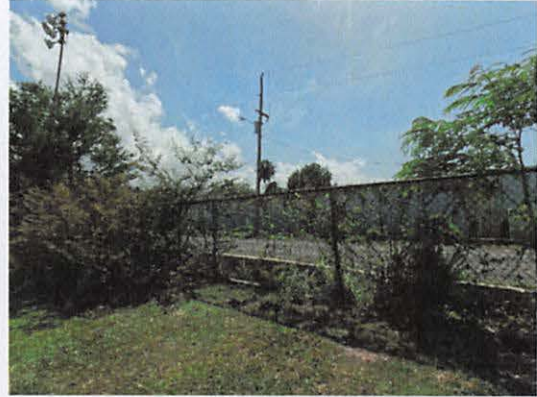
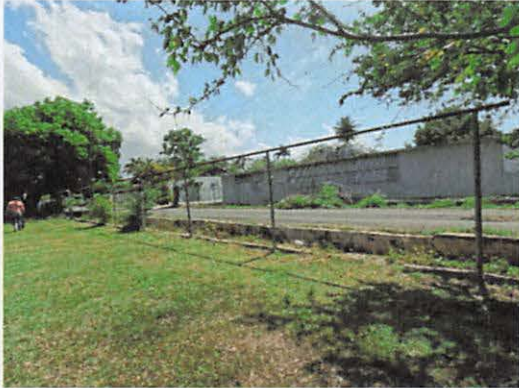
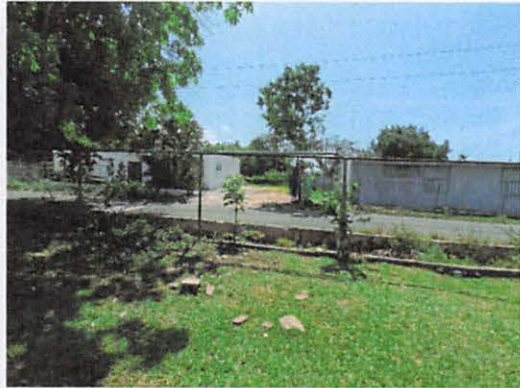
### ***Facility Damage - Chain Link Fences***

- 1) Remove and dispose of existing damaged 4' high chain link fence in the outfield area. 214 LF.
- 2) Supply and install new 4' high chain link fence in the outfield area. 214 LF.

- 3) Remove and dispose of existing damaged 6' high chain link fence:
  - a. From the parking lot to where the 4' high chain link fence starts: 230 LF.
  - b. From where the 4' high chain link fence ends to the end of the outfield semicircle in the left field: 220 LF.

- c. Remove and dispose of existing damaged single swing gate in the outfield area. 16 LF.
  - d. Remove and dispose of existing damaged double swing gate next to the restrooms structure. 12 LF.

- d. Supply and install new double swing gate next to the restrooms structure. 12 LF.
  - e. In front of the dugouts: 190 LF.
  - f. Total of 668 LF.
- 5) Remove and dispose of existing damaged 10' high chain link fence:

- 9) Refer to standard drawings for chain link fence and gates details.
- 10) Supply and install a new fence topper all along the perimeter of the outfield fence, and the fences in front of the dugouts. Equal or similar to model 01160 Poly-Cap by Baseball Fence Toppers. Approximately 824 LF.

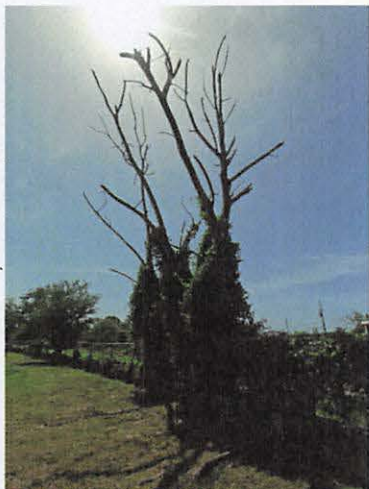
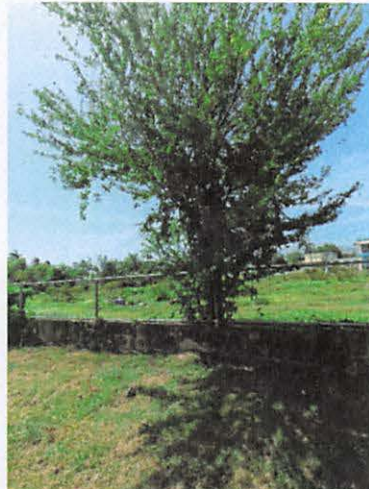
***Facility Damage - Vegetative and Non-Vegetative Debris***

- 1) Remove approximately 3 CY of vegetative debris.
- 2) Remove tree along the chain link fence in the outfield area. One (1) ea.

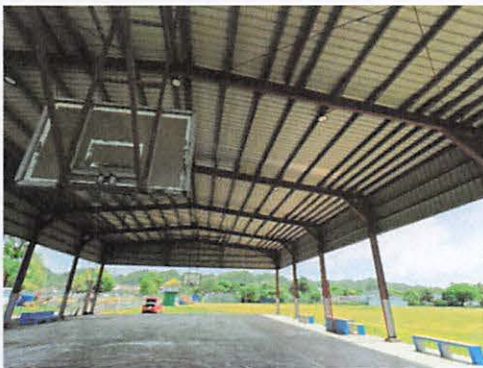
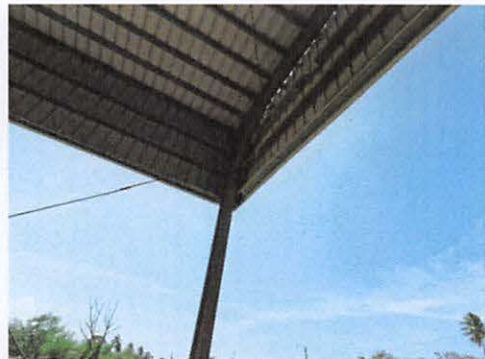
### ***Facility Damage - Basketball Court Roof Structure***

- 1) Remove, supply and repair by replacement of metal roof panels 36" x 32' in length. Eight (8) ea.
- 2) Repair damaged roof net. Approximately 7,700 SF.
- 3) Remove, supply and repair by replacement of trims. 180 LF.
- 4) Remove, supply and repair by replacement of gutters. 220 LF.
- 5) Remove, supply and repair by replacement of downspouts. 22 LF. 12 ea.
- 6) Remove, supply and repair by replacement of existing Type Z-10, purlins. 140 LF.
- 7) Remove, supply and repair by replacement of metal ridge panels 110' l x 10' w.
- 8) Paint all columns from the base to the roof siding's edge.
- 9) See paint notes.

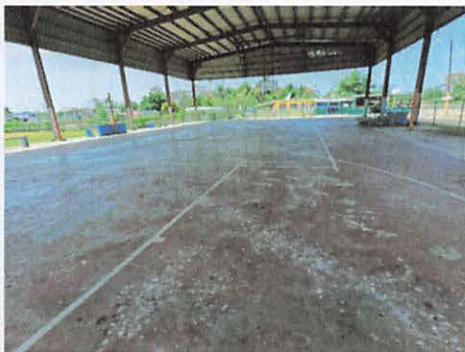
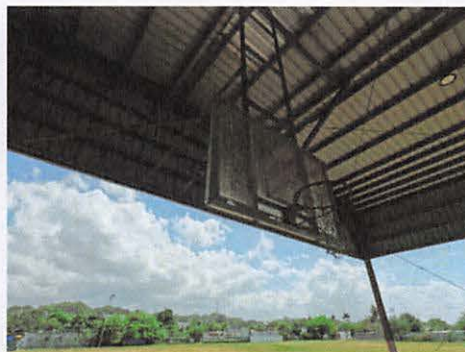
### ***Facility Damage - Basketball Court***

- 1) Remove existing basketball court markings. See Multisport Court Technical Specifications.
  - a. Apply a paint stripper.
  - b. Scrape away the paint.
  - c. Rinse the concrete with a pressure washer.
- 2) Supply and install new acrylic basketball goal boards. (2 ea.)
- 3) Supply and install new Volleyball Ground Sleeves Kits, equal to or similar to Jaypro PVB-75S. (2ea.)
- 4) Paint multisport court markings, volleyball net poles, and goal poles. See Multisport Court Technical Specifications.
- 5) See paint in general specifications.
- 6) Color to be selected by owner.
- 7) See paint notes.
- 8) Dimensions: 70' w x 110' l.

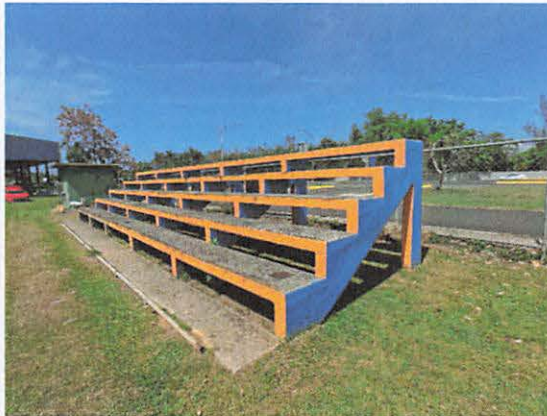
### ***Facility Damage – Bleachers***

- 1) Repair concrete bleacher sections:
  - a. Chip existing loose concrete and treat the exposed rebar. Clean exposed rebar with a steel brush and apply Loctite Extend Rust Neutralizer.
  - b. Apply bonding primer and reinforcement corrosion protection.
  - c. Clean, patch and finish the affected area with Vinyl Concrete Patch.
- 2) Paint existing bleachers. See paint notes.
- 3) Dimensions: 10' w x 43' l x 80" h. One (1) ea.
- 4) Construct new metal roof structure for the bleachers area. Approximately 799 SF.
- 5) Install new gutters (47 LF) and downspouts (35 LF).
- 6) Install edge trim 81 LF.
- 7) Supply and install new steel handrails. See details. (63 LF).

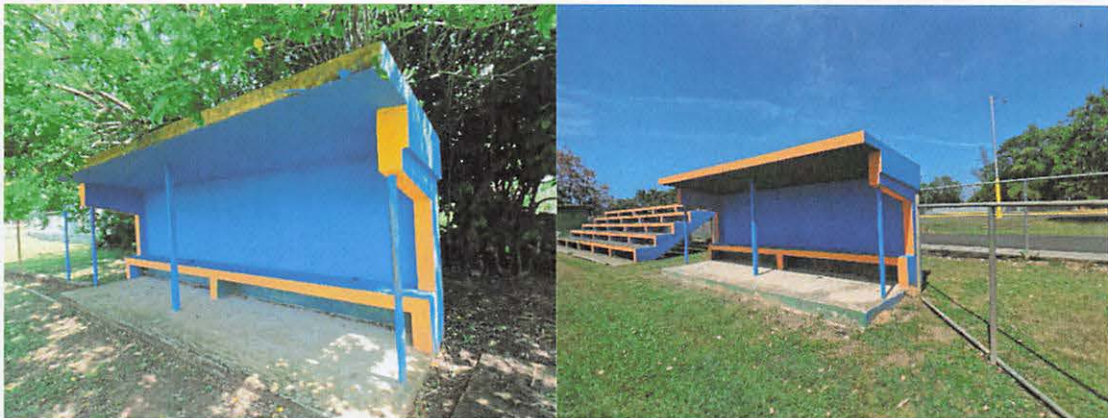
### ***Facility Damage – Dugouts***

- 1) Spalling Concrete Repair - Chip existing loose concrete and treat the exposed rebar. Clean exposed rebar with a steel brush and apply Loctite Extend Rust Neutralizer.
- 2) Apply bonding primer and reinforcement corrosion protection.
- 3) Patch and finish the affected area with Vinyl Concrete Patch.
- 4) Thin set concrete resurfacing of existing dugout floors. Equal or similar to NewCrete concrete Resurfacer by Rapid Set.
- 5) 6' w x 20' l. Two (2) ea.

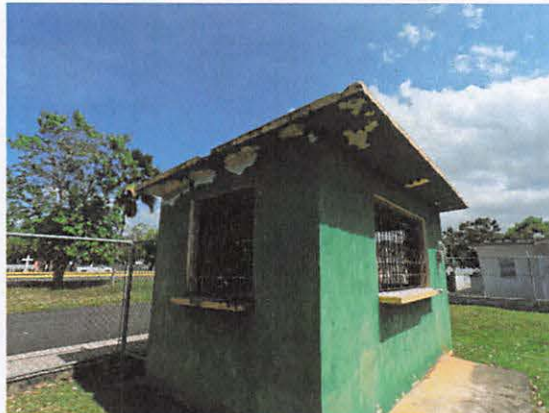
### ***Facility Damage – Canteen***

- 1) Spalling Concrete Repair - Chip existing loose concrete and treat the exposed rebar. Clean exposed rebar with a steel brush and apply Loctite Extend Rust Neutralizer.
- 2) Apply bonding primer and reinforcement corrosion protection.
- 3) Patch and finish the affected area with Vinyl Concrete Patch.
- 4) 15' w x 17' l.
- 5) Pressure wash cleaning of existing concrete roof and interior of restrooms. Approximately 255 SF.
- 6) Installation of new waterproofing system. 357 SF approximately. Equal or similar to Danosa Richport modified. The contractor shall provide a 5 YR warranty. Installation of product must be as recommended by the manufacturer.

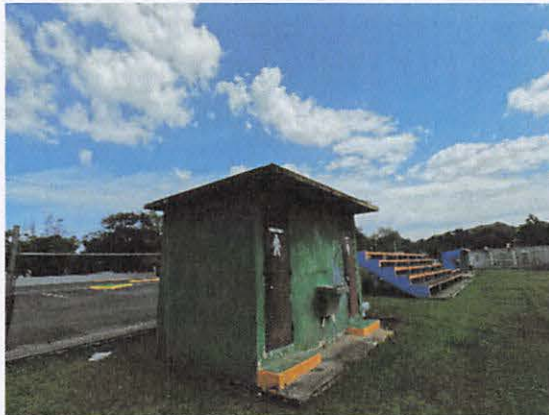
### ***Facility Damage – Restrooms Structure***

- 1) Spalling Concrete Repair - Chip existing loose concrete and treat the exposed rebar. Clean exposed rebar with a steel brush and apply Loctite Extend Rust Neutralizer.

- 2) Apply bonding primer and reinforcement corrosion protection.
- 3) Patch and finish the affected area with Vinyl Concrete Patch.
- 4) 14' w x 11' l.
- 5) Pressure wash cleaning of existing concrete roof.

- 6) Installation of new waterproofing system. 154 SF approximately. Equal or similar to Danosa Richport modified. The contractor shall provide a 5 YR warranty. Installation of product must be as recommended by the manufacturer.

- 7) Remove and dispose of all restroom equipment: two (2) toilets, two (2) lavatories, one (1) urinal, toilet partitions, and accessories.
- 8) Repair existing concrete wall plaster finish with the application of new wall finish product as manufactured by Master (equal or similar), used to renovate walls and ceilings.

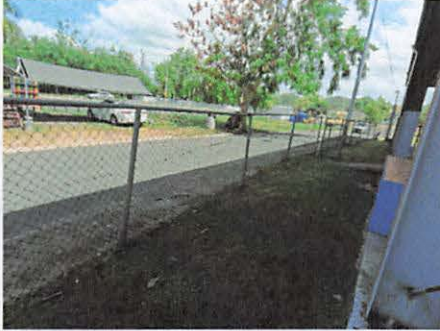
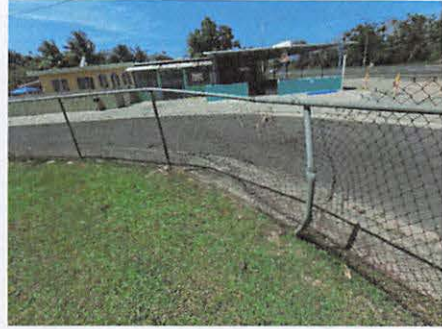
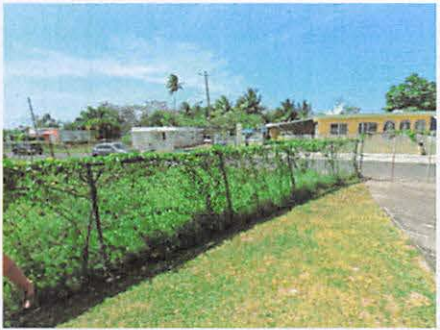
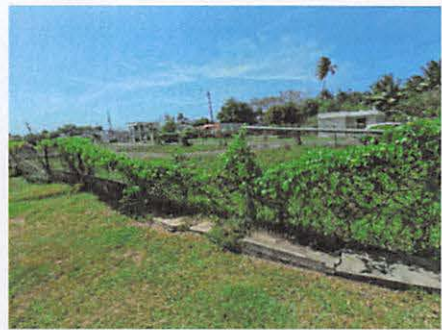
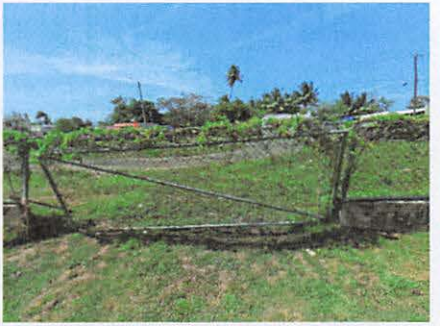
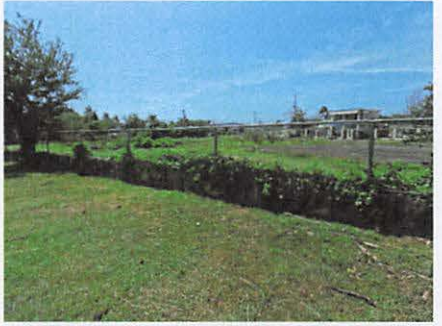
### ***Facility Damage - Chain Link Fences***

- 1) Remove and dispose of existing damaged 4' high chain link fence in the outfield area. 214 LF.
- 2) Supply and install new 4' high chain link fence in the outfield area. 214 LF.

- 3) Remove and dispose of existing damaged 6' high chain link fence:
  - a. From the parking lot to where the 4' high chain link fence starts: 230 LF.
  - b. From where the 4' high chain link fence ends to the end of the outfield semicircle in the left field: 220 LF.

- c. Remove and dispose of existing damaged single swing gate in the outfield area. 16 LF.
  - d. Remove and dispose of existing damaged double swing gate next to the restrooms structure. 12 LF.

- d. Supply and install new double swing gate next to the restrooms structure. 12 LF.
  - e. In front of the dugouts: 190 LF.
  - f. Total of 668 LF.
- 5) Remove and dispose of existing damaged 10' high chain link fence:

- 7) Supply and install new 16' high chain link fence in front of bleachers. 43 LF.
- 8) Paint backstop pipes. Use metallic aluminum color oil base paint. See paint notes.

- 9) Refer to standard drawings for chain link fence and gates details.
- 10) Supply and install a new fence topper all along the perimeter of the outfield fence, and the fences in front of the dugouts. Equal or similar to model 01160 Poly-Cap by Baseball Fence Toppers. Approximately 824 LF.

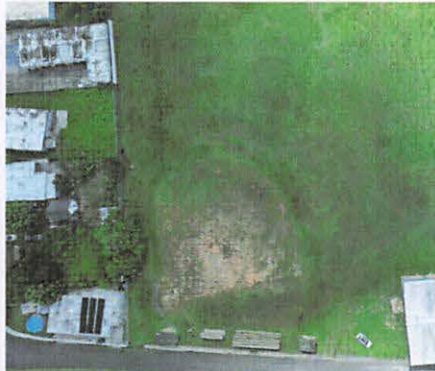
### **Baseball Field - Field Work**

- 1) The contractor is responsible for the repair of the existing damaged infield.
  - Remove all grown sod inside the infield area and apply an industrial herbicide to prevent future grow.
  - Rake the area and remove all debris.
  - To repair the infield surface, use a mix equal to 55 percent sand, 30 percent clay, and 15 percent silt covering material.
  - Prepare the lawn area as recommended by the guide provided.
  - Follow the guide provided. (Where apply)
  - Install baseball bases set.

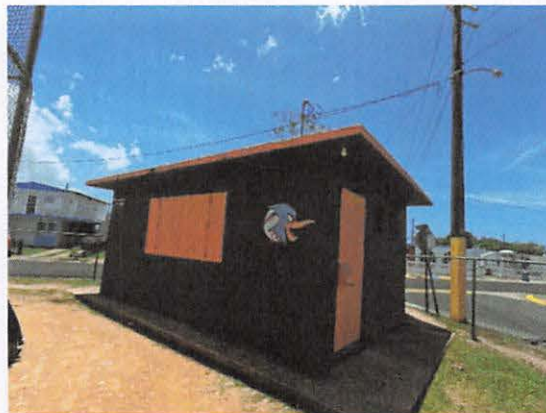
### **Facility Damage – Baseball Field *Canteen / Restrooms***

- 1) Spalling Concrete - Chip existing loose concrete and treat the exposed rebar. Clean exposed rebar with a steel brush and apply Loctite Extend Rust Neutralizer.

- 2) Apply bonding primer and reinforcement corrosion protection.
- 3) Patch and finish the affected area with Vinyl Concrete Patch.
- 4) 25' w x 16' l.
- 5) Pressure wash cleaning of existing concrete roof. 400 SF.

- 6) Installation of new waterproofing system. 400 SF. Equal or similar to Danosa RM 5 modified bitumen membrane. The contractor shall provide a 10 YR warranty. Installation of product must be as recommended by the manufacturer.

- 7) Paint existing Canteen (Interior and Exterior). See paint notes. Paint all existing painted surfaces, unless otherwise noted.
- 8) Interior painting Canteen and Restrooms area 1352 SF Approx.
